repairs to the TOWERS OF PONCE INLET - BUILDING 500 4545 South Atlantic Avenue Ponce Inlet, Florida

λ		
			PI	ROJECT DIRECTORY	INDEX of DI	RAWINGS	
			ENGINEER OF REC	•	S-0 COVER SHEET		
					S-1 CONCRETE REPAIR PRO	OCEDURES & DETAILS	
					S-2 1ST FLOOR REPAIR PLAN		
						S-2IbTTECONTREPARTEMENTERS-32ND FLOOR REPAIR PLANS-43RD FLOOR REPAIR PLAN	
		XIII.					
						S-5 4TH FLOOR REPAIR PLA	
					Charles R. Adams	S-6 5TH FLOOR REPAIR PL	
					& Associates, Inc.	S-7 6TH FLOOR REPAIR PL	AN
				s s	TRUCTURAL ENGINEERS	S-8 7TH FLOOR REPAIR PL	AN
				414 Canal Street -	New Smyrna Beach, FL 32168 - 386.426.5583	S-9 ROOF REPAIR PLAN	
				TTT Canal Street -	C.R. 4180		
Land and the second					0.11. 4100		
	the same and the			ARCHITECT:			
LOCATION MAP		ABBRI	EVIATIONS	_	N/A		
		AC	AIR CONDITIONING	-			
A REAL PROPERTY AND A REAL		AFF ALUM	ABOVE FINISHED FLOOR ALUMINUM				
		CLG CMU	CEILING CONCRETE MASONRY UNIT				
		COLCOLUMNCONCCONCRETE		GENERAL CONTRACTOR:		SCOPE O	FWORK
		CONT C/L	CONTINUOUS CENTER LINE	T.B.D.		COMMERCIAL - CONCRETE REPAIRS

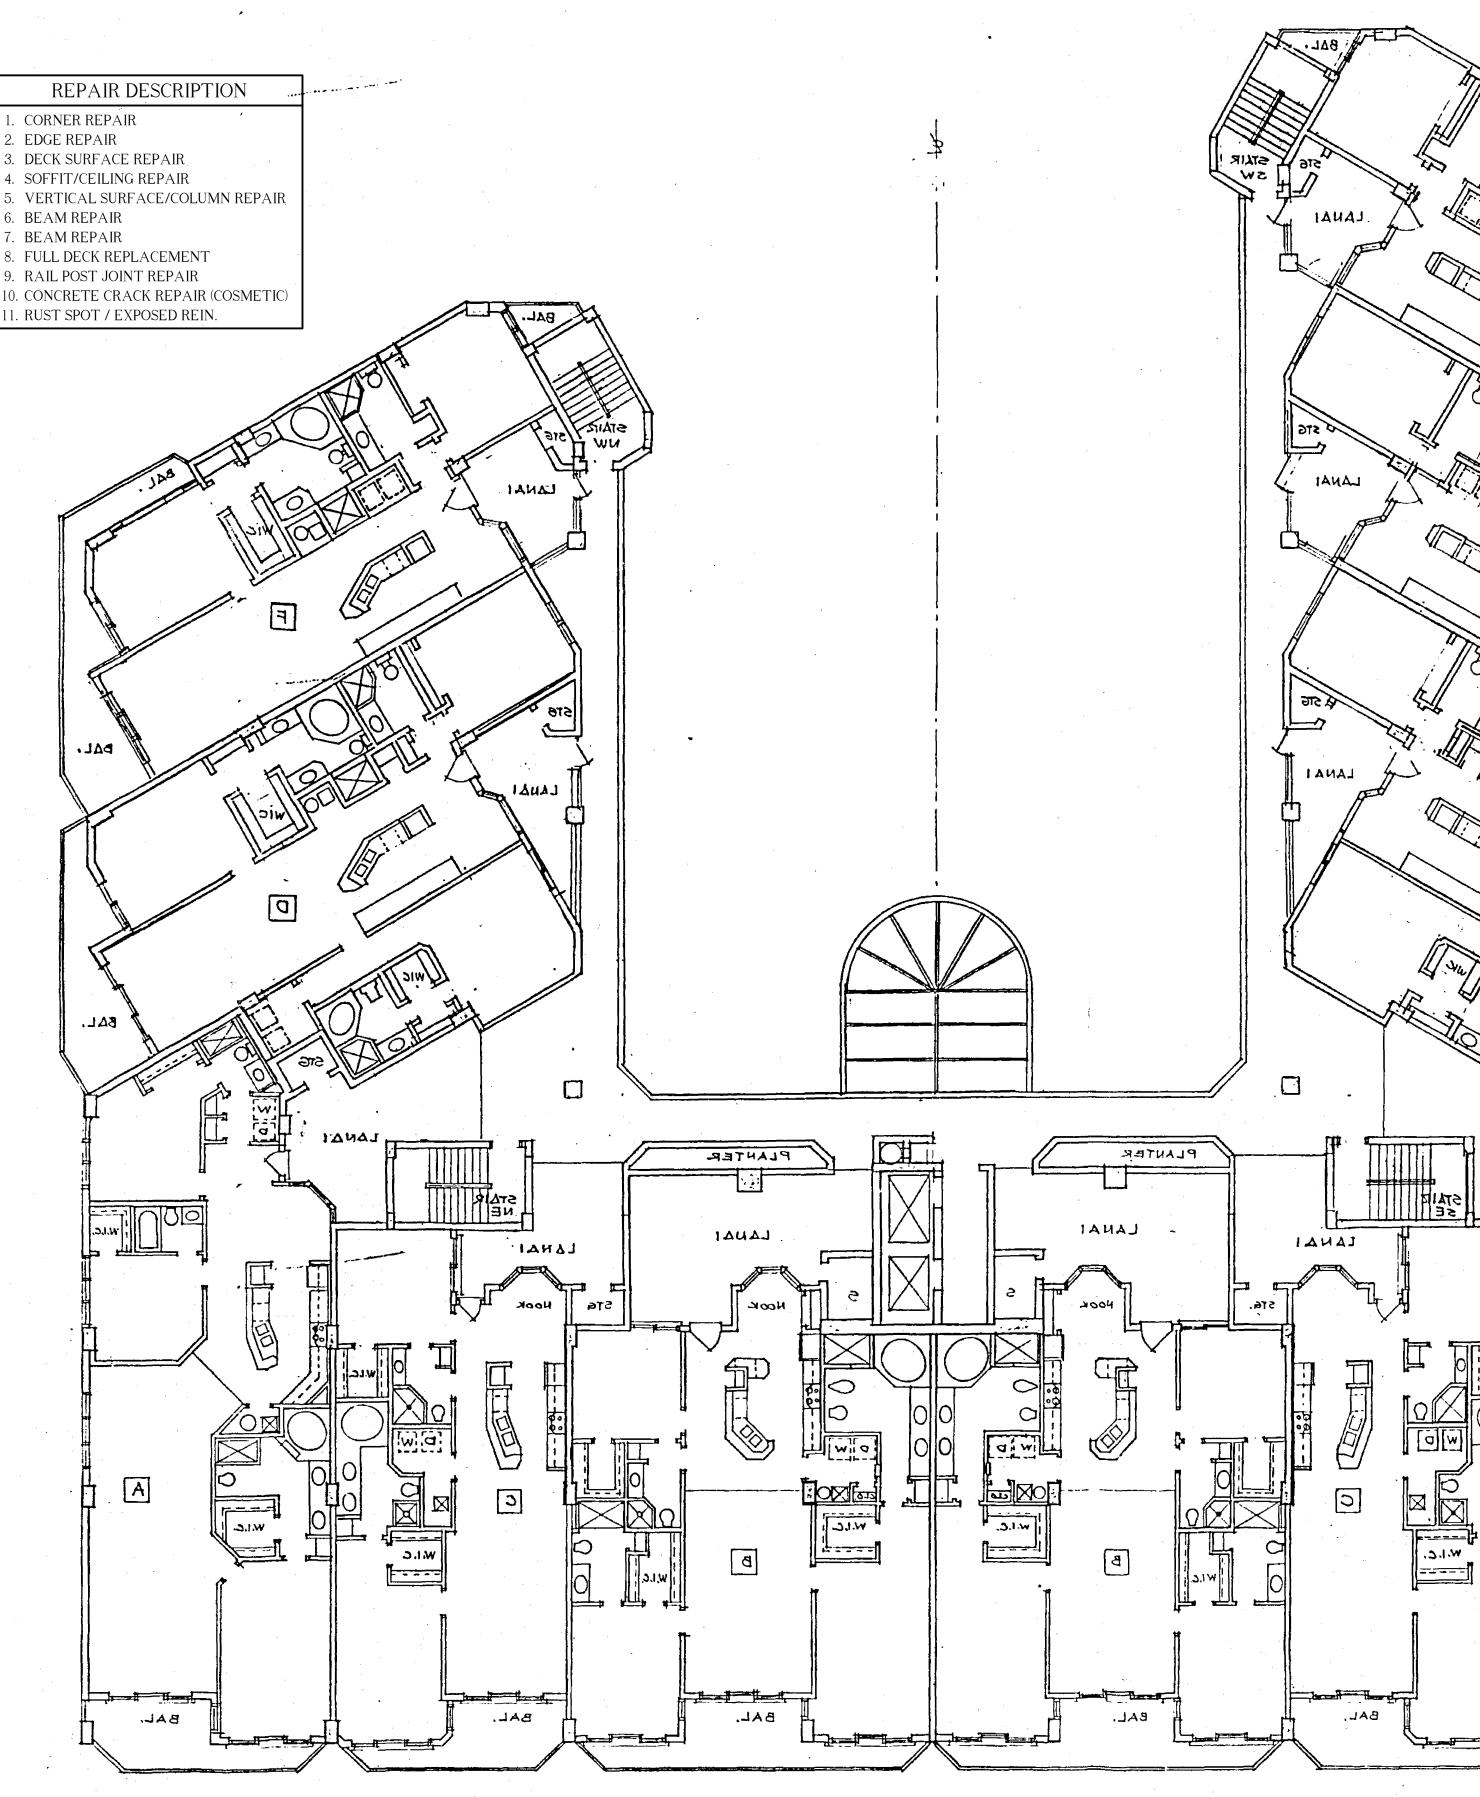
- 1. CORNER REPAIR
- 4. SOFFIT/CEILING REPAIR
- BEAM REPAIR

- 11. RUST SPOT / EXPOSED REIN.

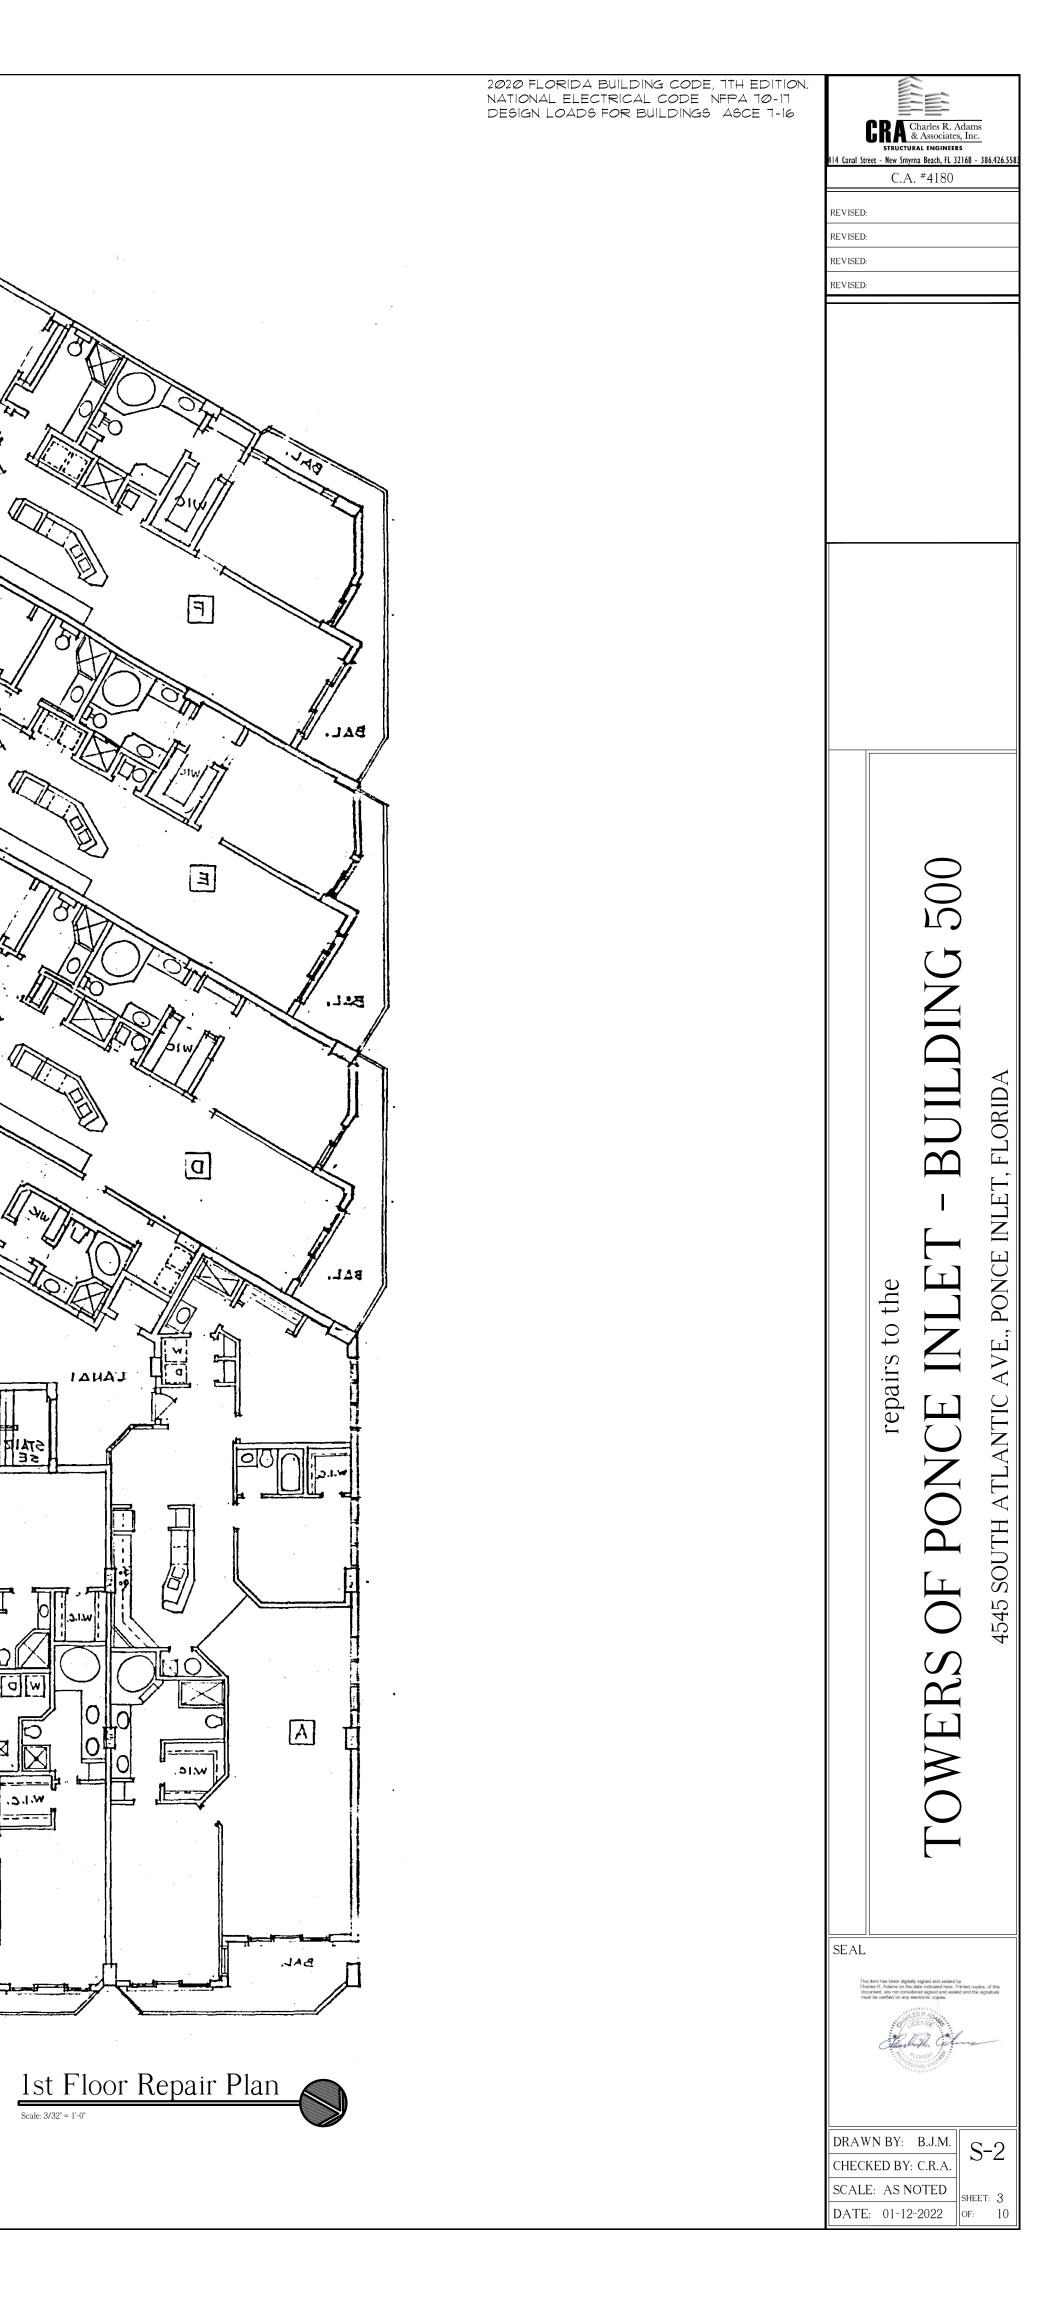
NO STRUCTURAL ISSUES DISCOVERED

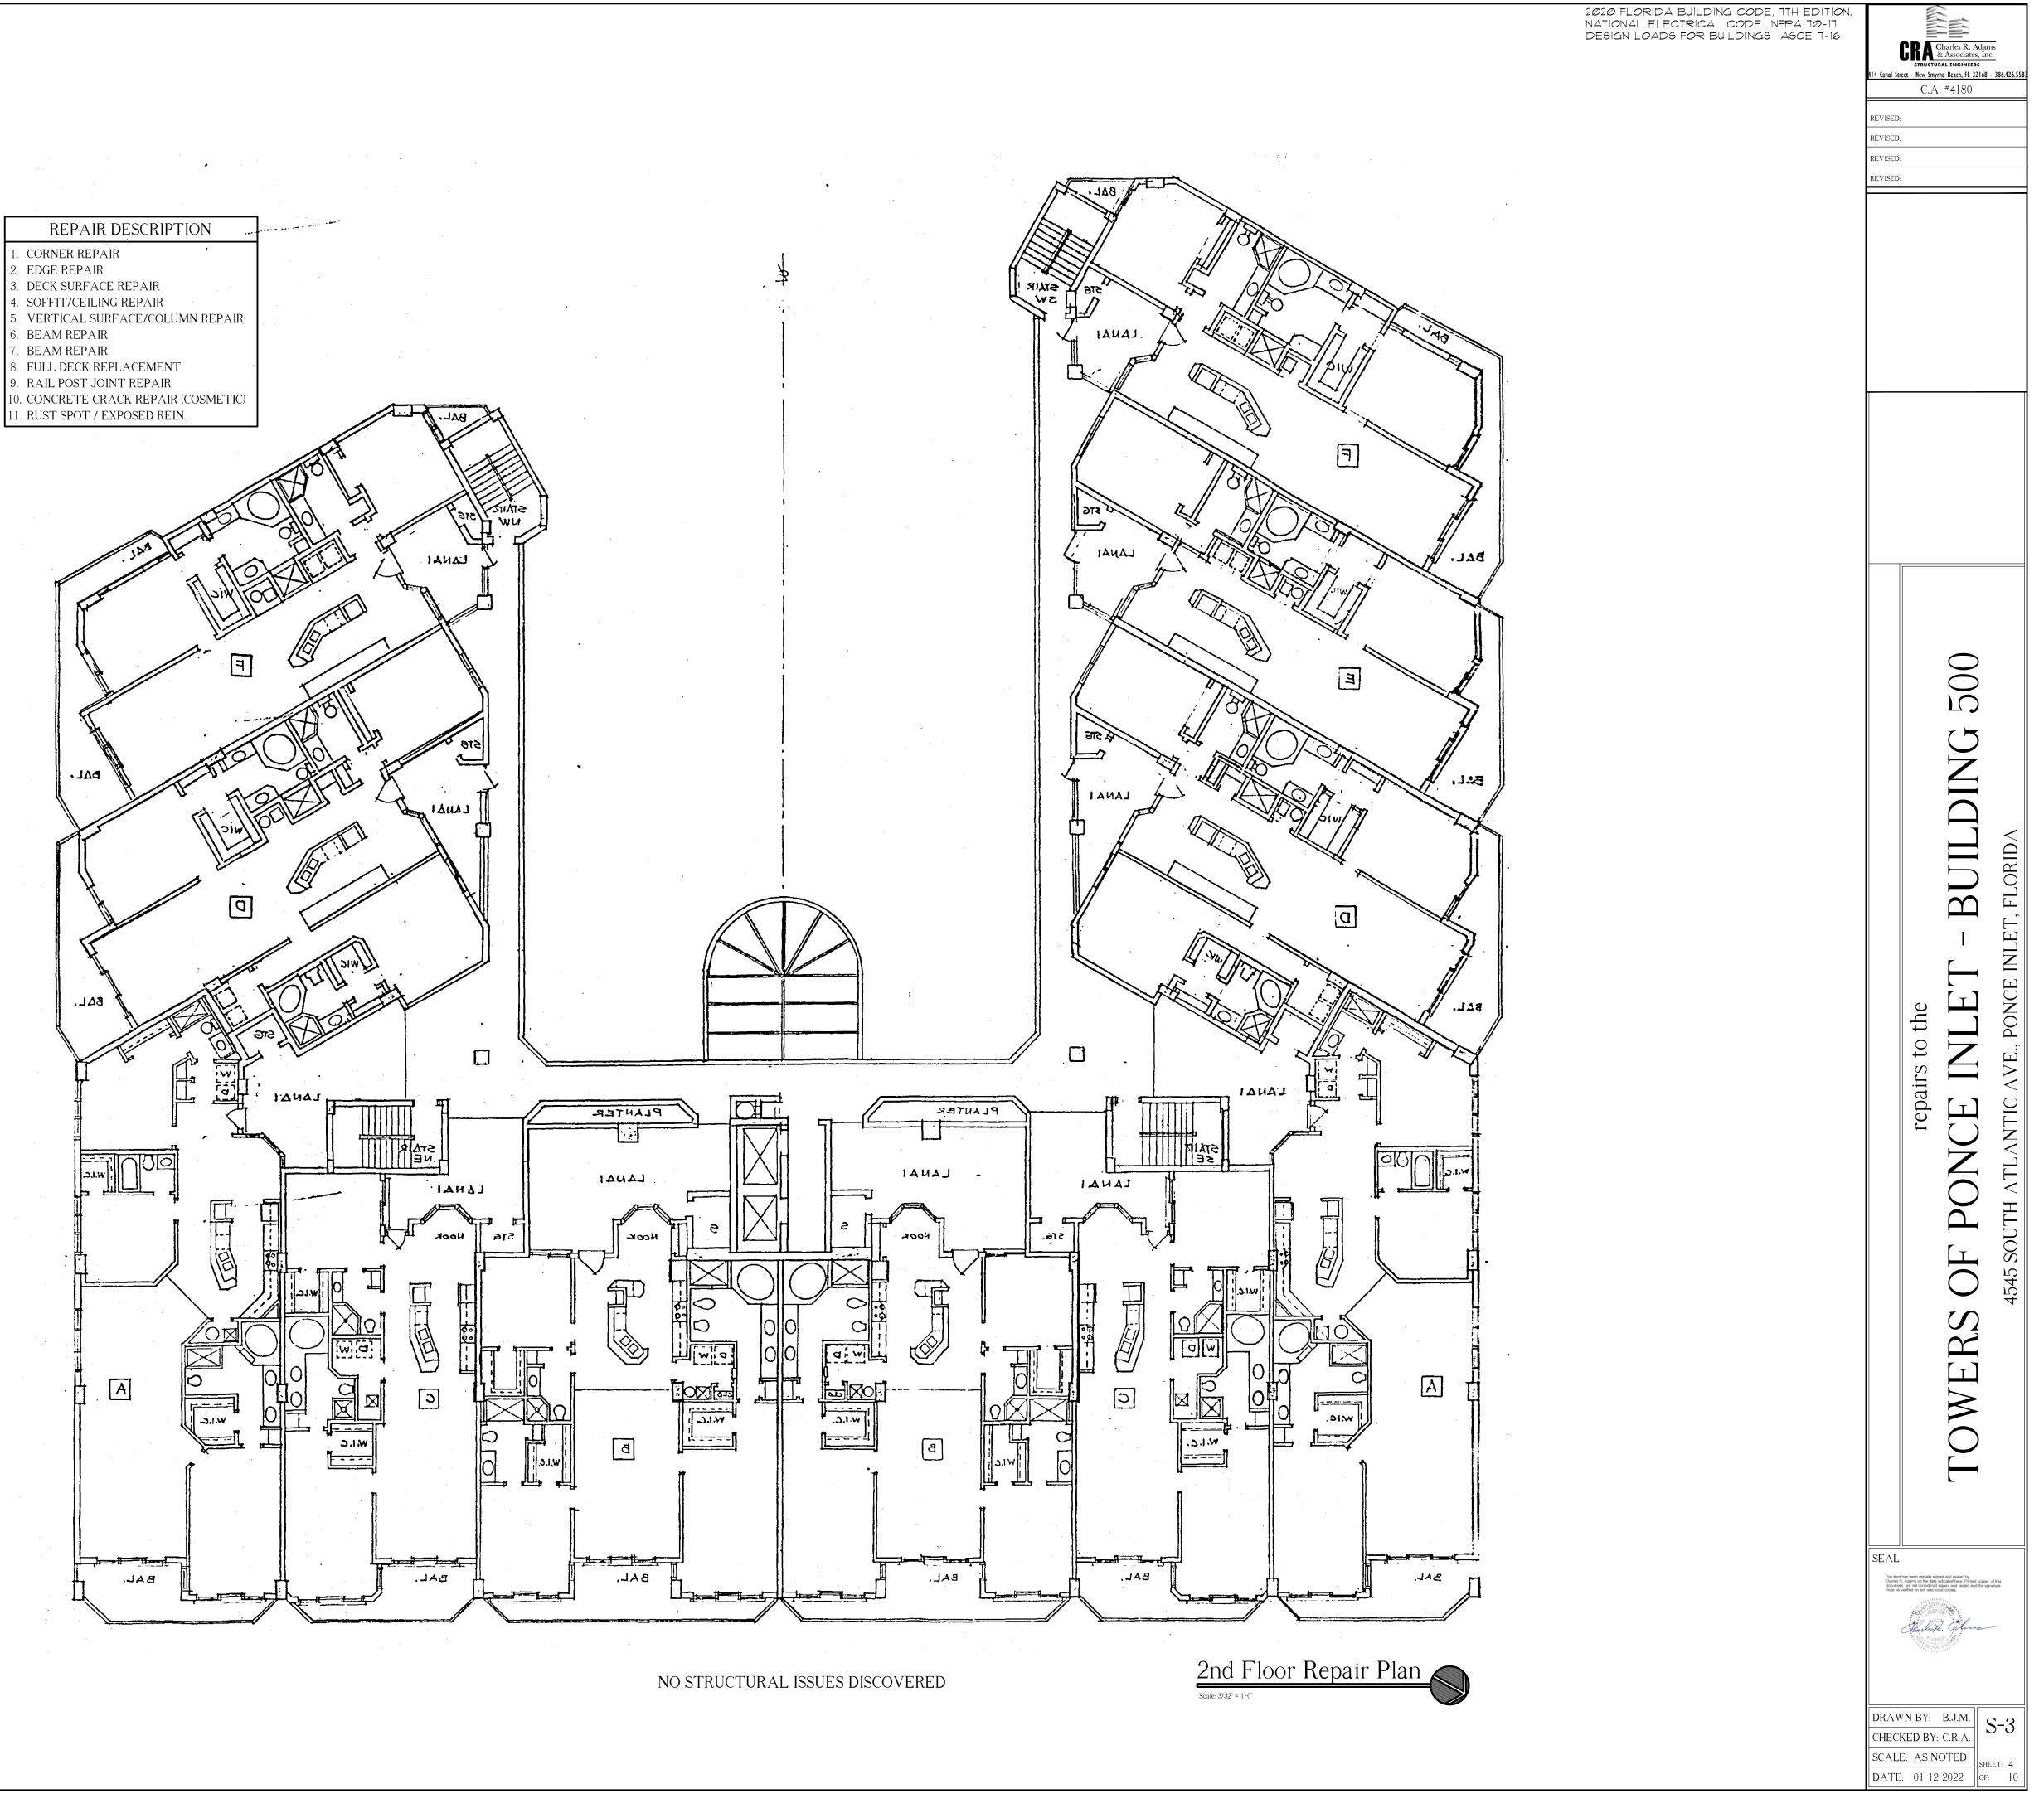
- 1. CORNER REPAIR
- 4. SOFFIT/CEILING REPAIR
- . BEAM REPAIR

- 9. RAIL POST JOINT REPAIR

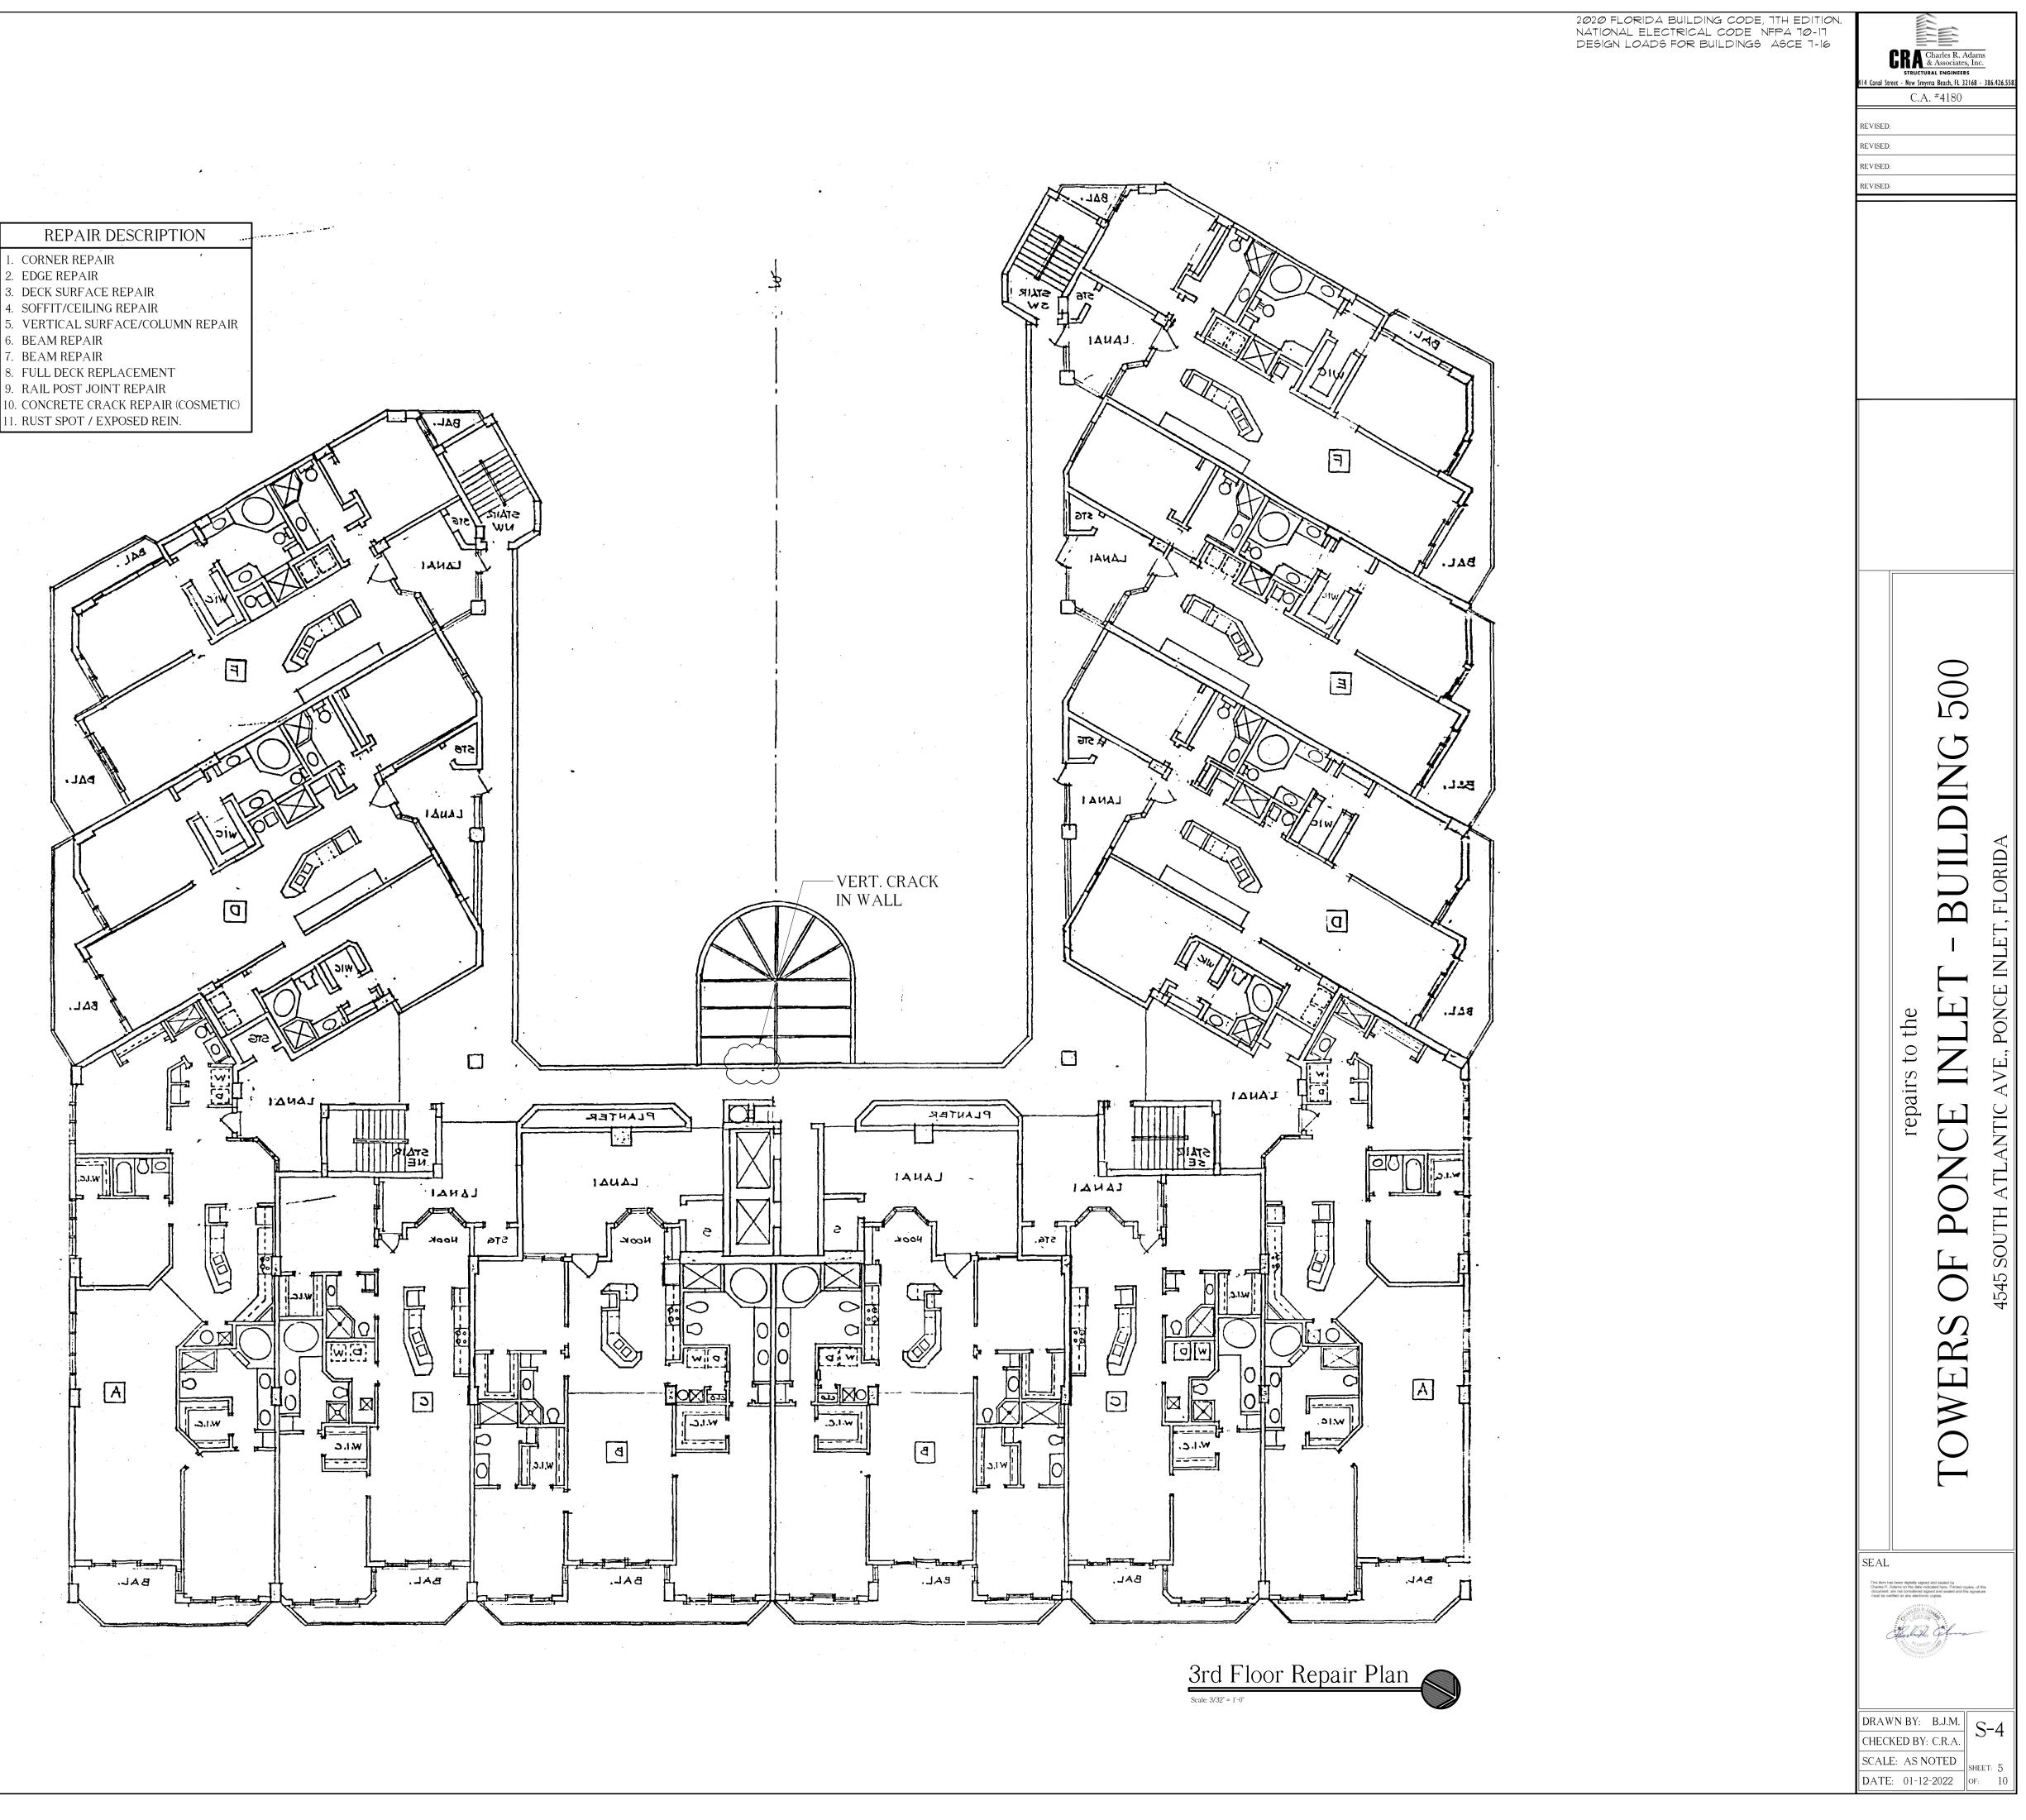
- 1. CORNER REPAIR
- 2. EDGE REPAIR
- 5. VERTICAL SURFACE/COLUMN REPAIR
- 5. BEAM REPAIR
- BEAM REPAIR
- 9. RAIL POST JOINT REPAIR
- 11. RUST SPOT / EXPOSED REIN.

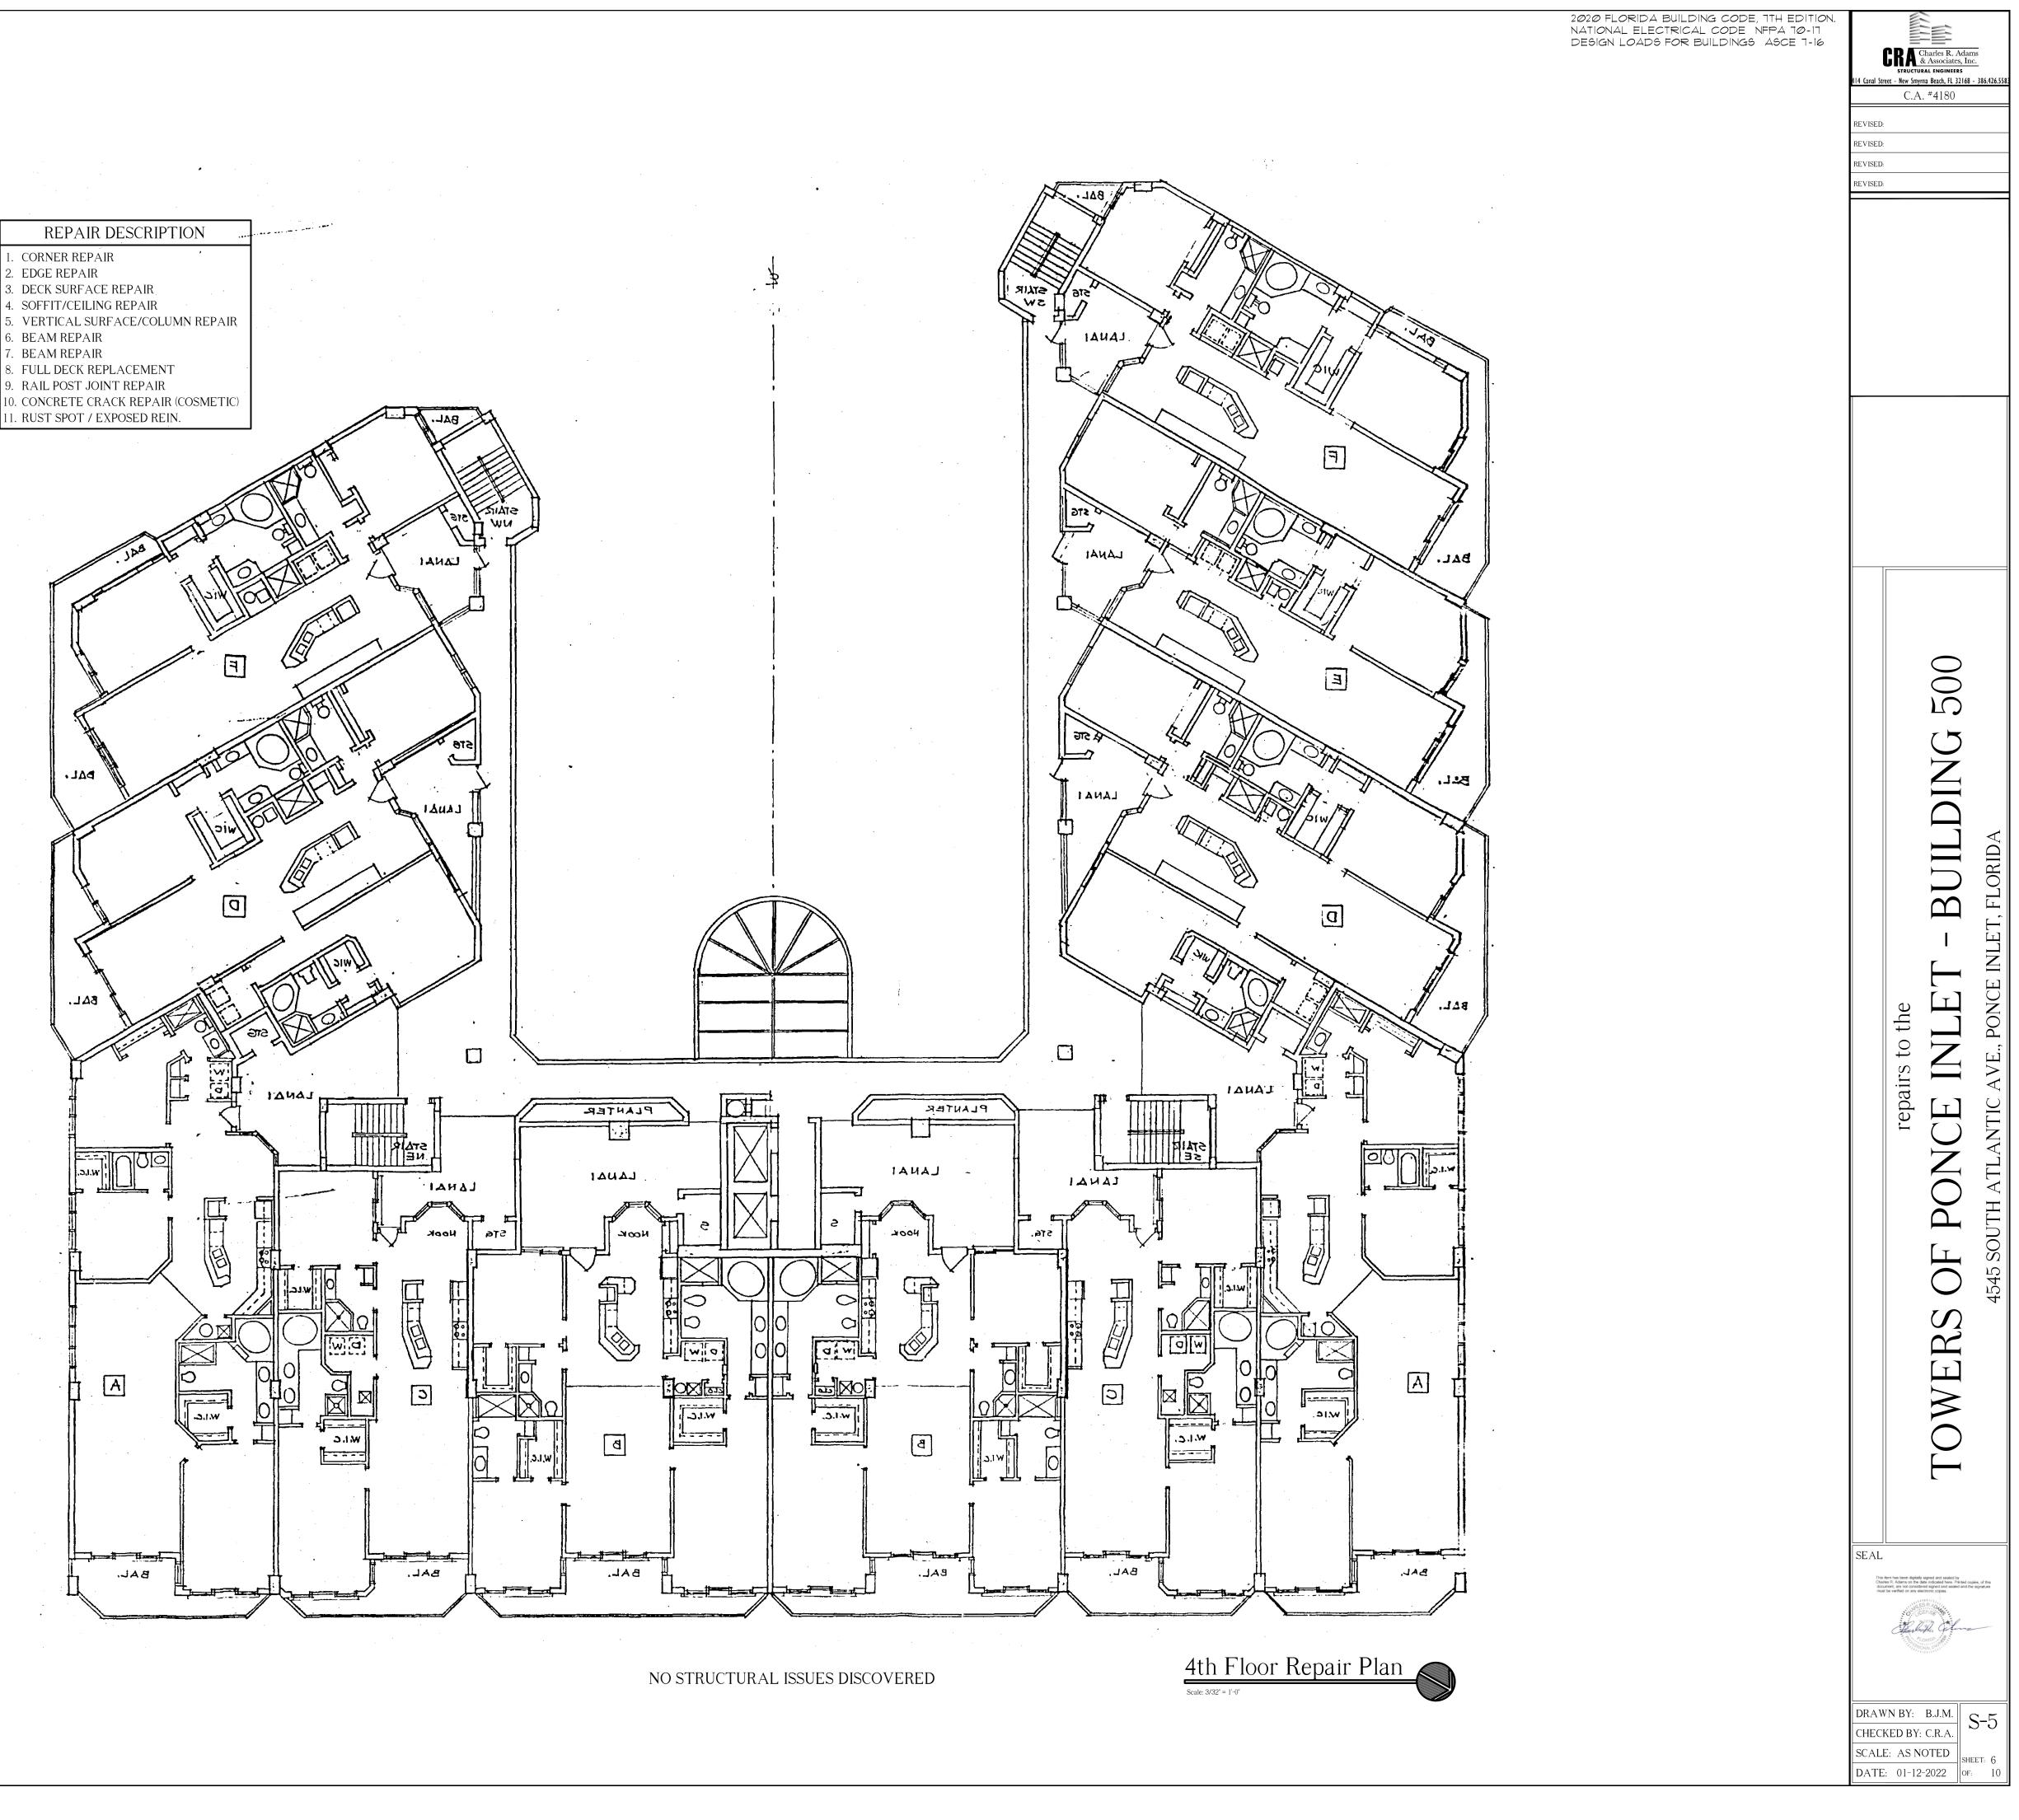
- 1. CORNER REPAIR
- 4. SOFFIT/CEILING REPAIR
- 5. BEAM REPAIR BEAM REPAIR
- 9. RAIL POST JOINT REPAIR
- 11. RUST SPOT / EXPOSED REIN.

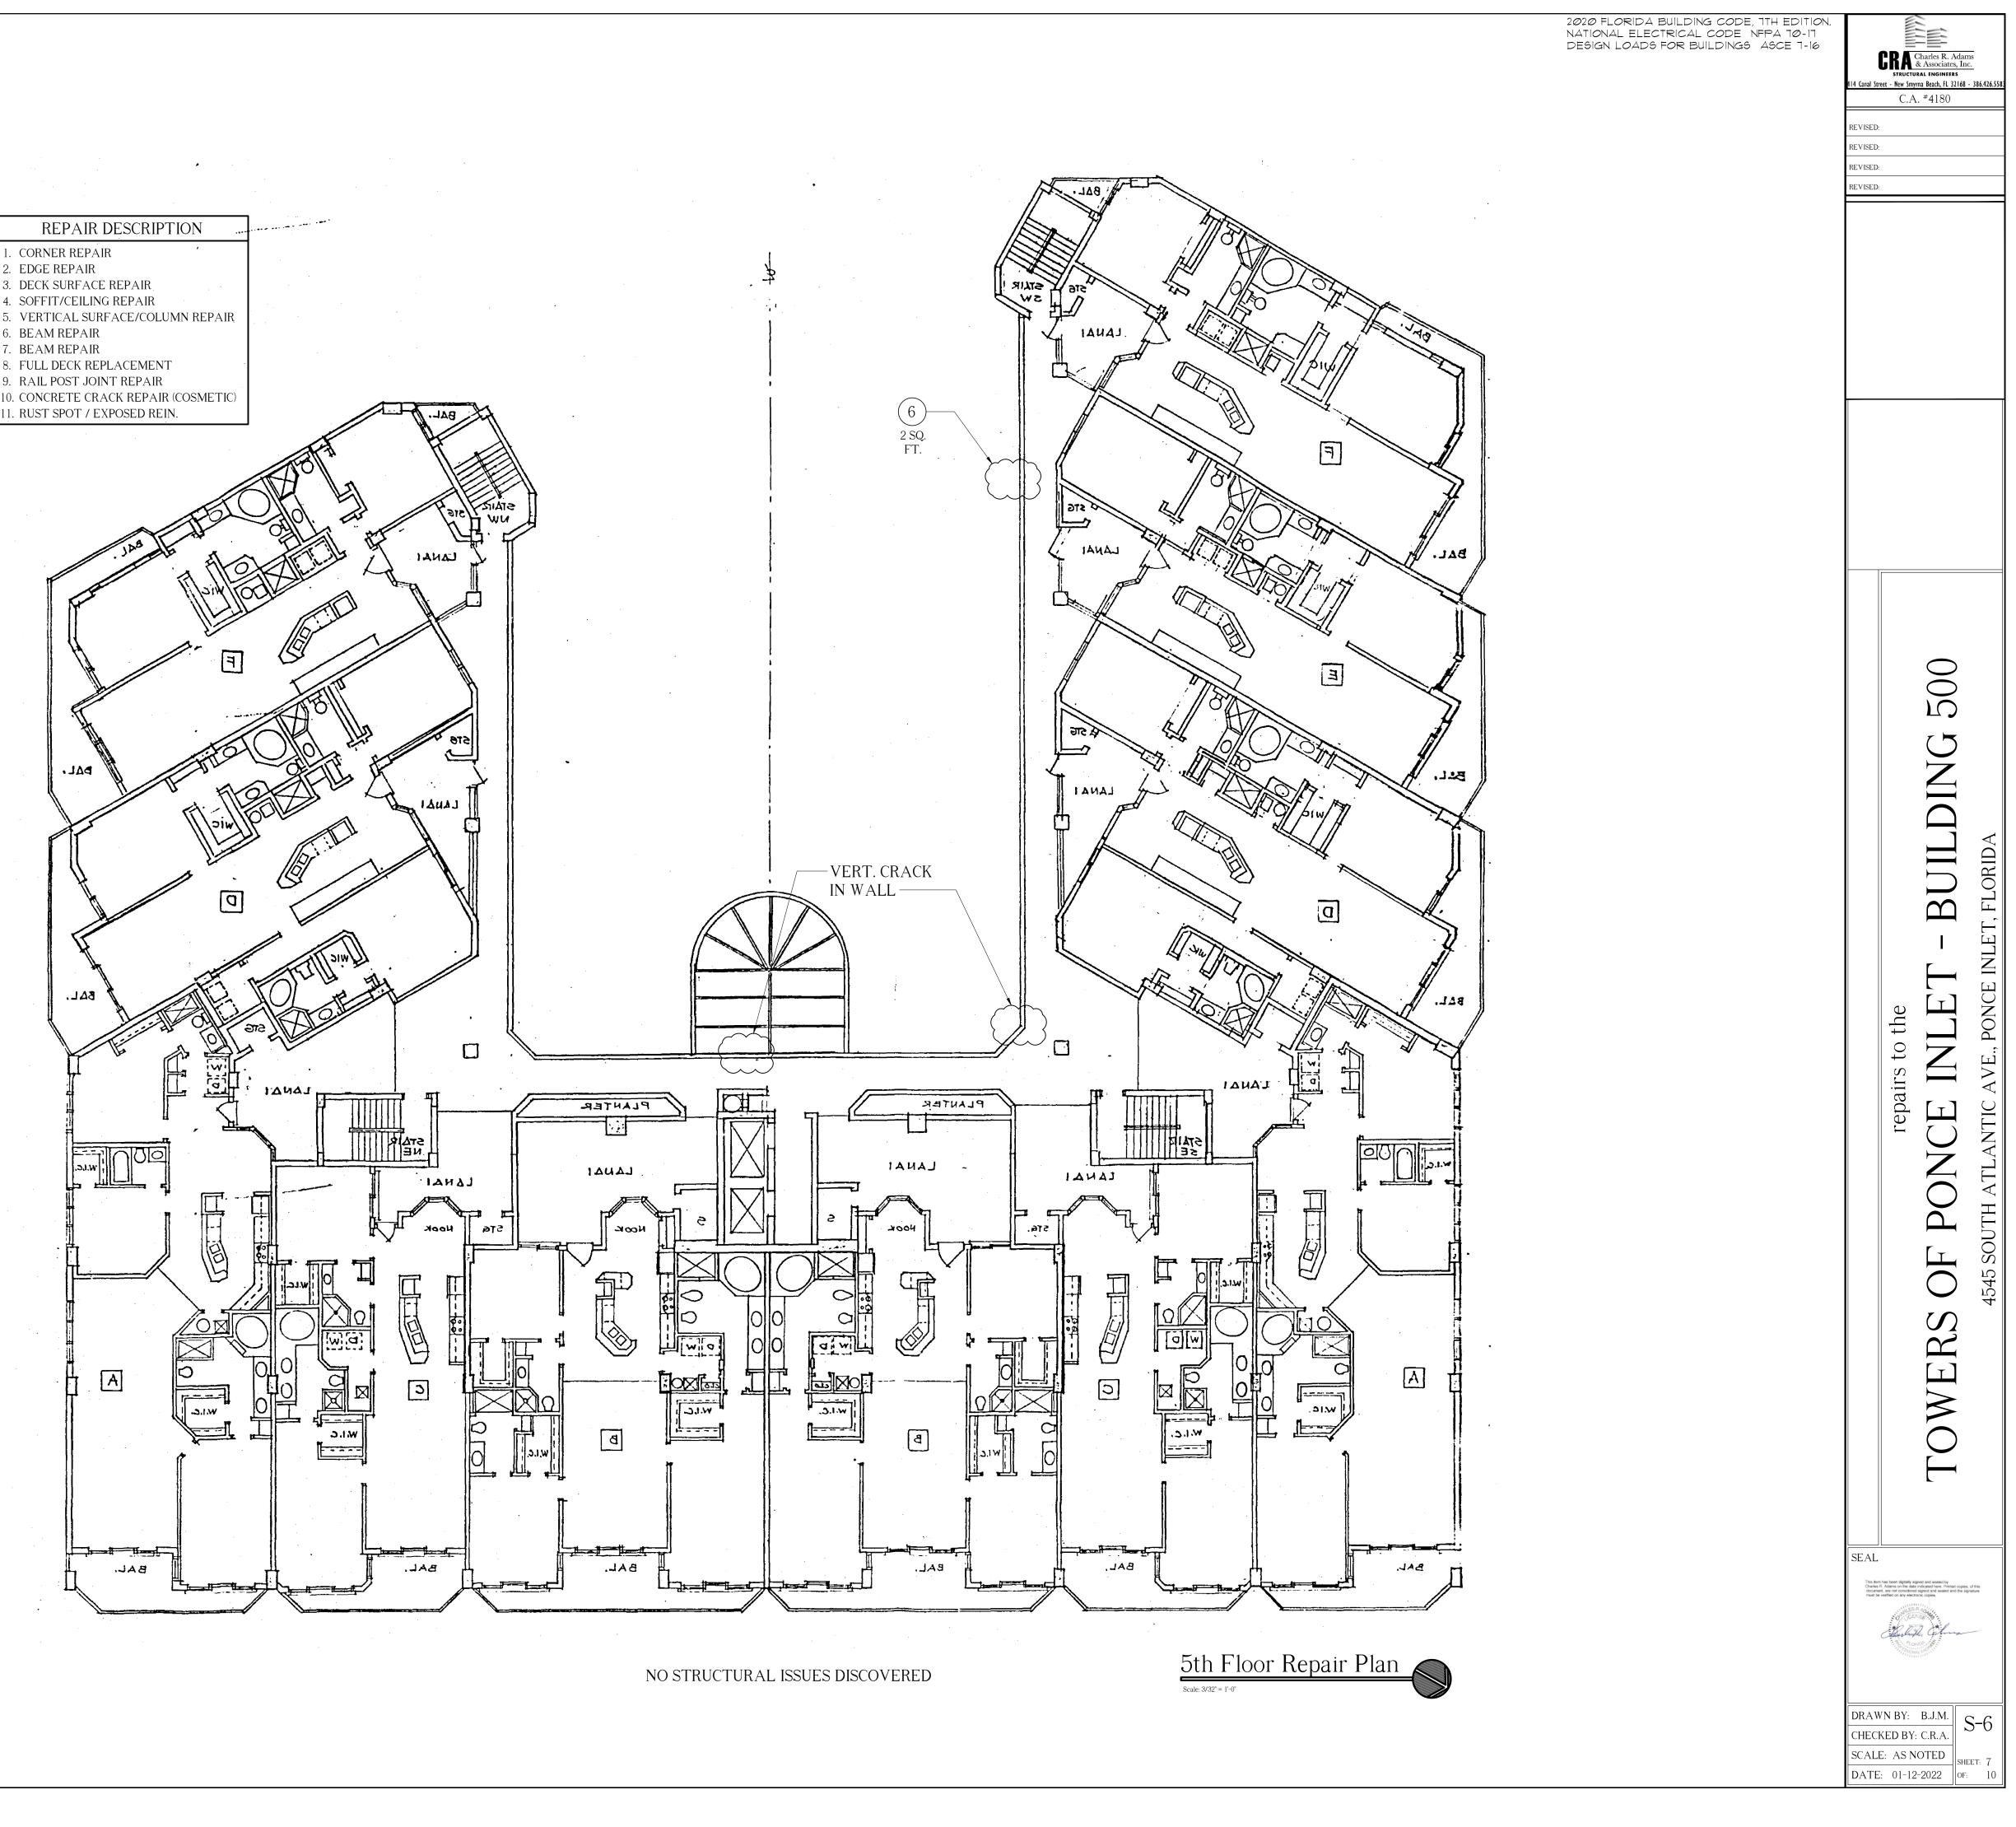
- 4. SOFFIT/CEILING REPAIR
- BEAM REPAIR
- **BEAM REPAIR**

- 1. RUST SPOT / EXPOSED REIN.
