repairs to the TOWERS OF PONCE INLET - BUILDING 500 4545 South Atlantic Avenue Ponce Inlet, Florida

λ		
			PI	ROJECT DIRECTORY	INDEX of DI	RAWINGS	
			ENGINEER OF REC	•	S-0 COVER SHEET		
					S-1 CONCRETE REPAIR PRO	OCEDURES & DETAILS	
					S-2 1ST FLOOR REPAIR PLAN		
						S-2IbTTECONTREPARTEMENTERS-32ND FLOOR REPAIR PLANS-43RD FLOOR REPAIR PLAN	
		XIII.					
						S-5 4TH FLOOR REPAIR PLA	
					Charles R. Adams	S-6 5TH FLOOR REPAIR PL	
					& Associates, Inc.	S-7 6TH FLOOR REPAIR PL	AN
				s s	TRUCTURAL ENGINEERS	S-8 7TH FLOOR REPAIR PL	AN
				414 Canal Street -	New Smyrna Beach, FL 32168 - 386.426.5583	S-9 ROOF REPAIR PLAN	
				TTT Canal Street -	C.R. 4180		
Land and the second					0.11. 4100		
	the same and the			ARCHITECT:			
LOCATION MAP		ABBRI	EVIATIONS	_	N/A		
		AC	AIR CONDITIONING	-			
A REAL PROPERTY AND A REAL		AFF ALUM	ABOVE FINISHED FLOOR ALUMINUM				
		CLG CMU	CEILING CONCRETE MASONRY UNIT				
		COLCOLUMNCONCCONCRETE		GENERAL CONTRACTOR:		SCOPE O	FWORK
		CONT C/L	CONTINUOUS CENTER LINE	T.B.D.		COMMERCIAL - CONCRETE REPAIRS

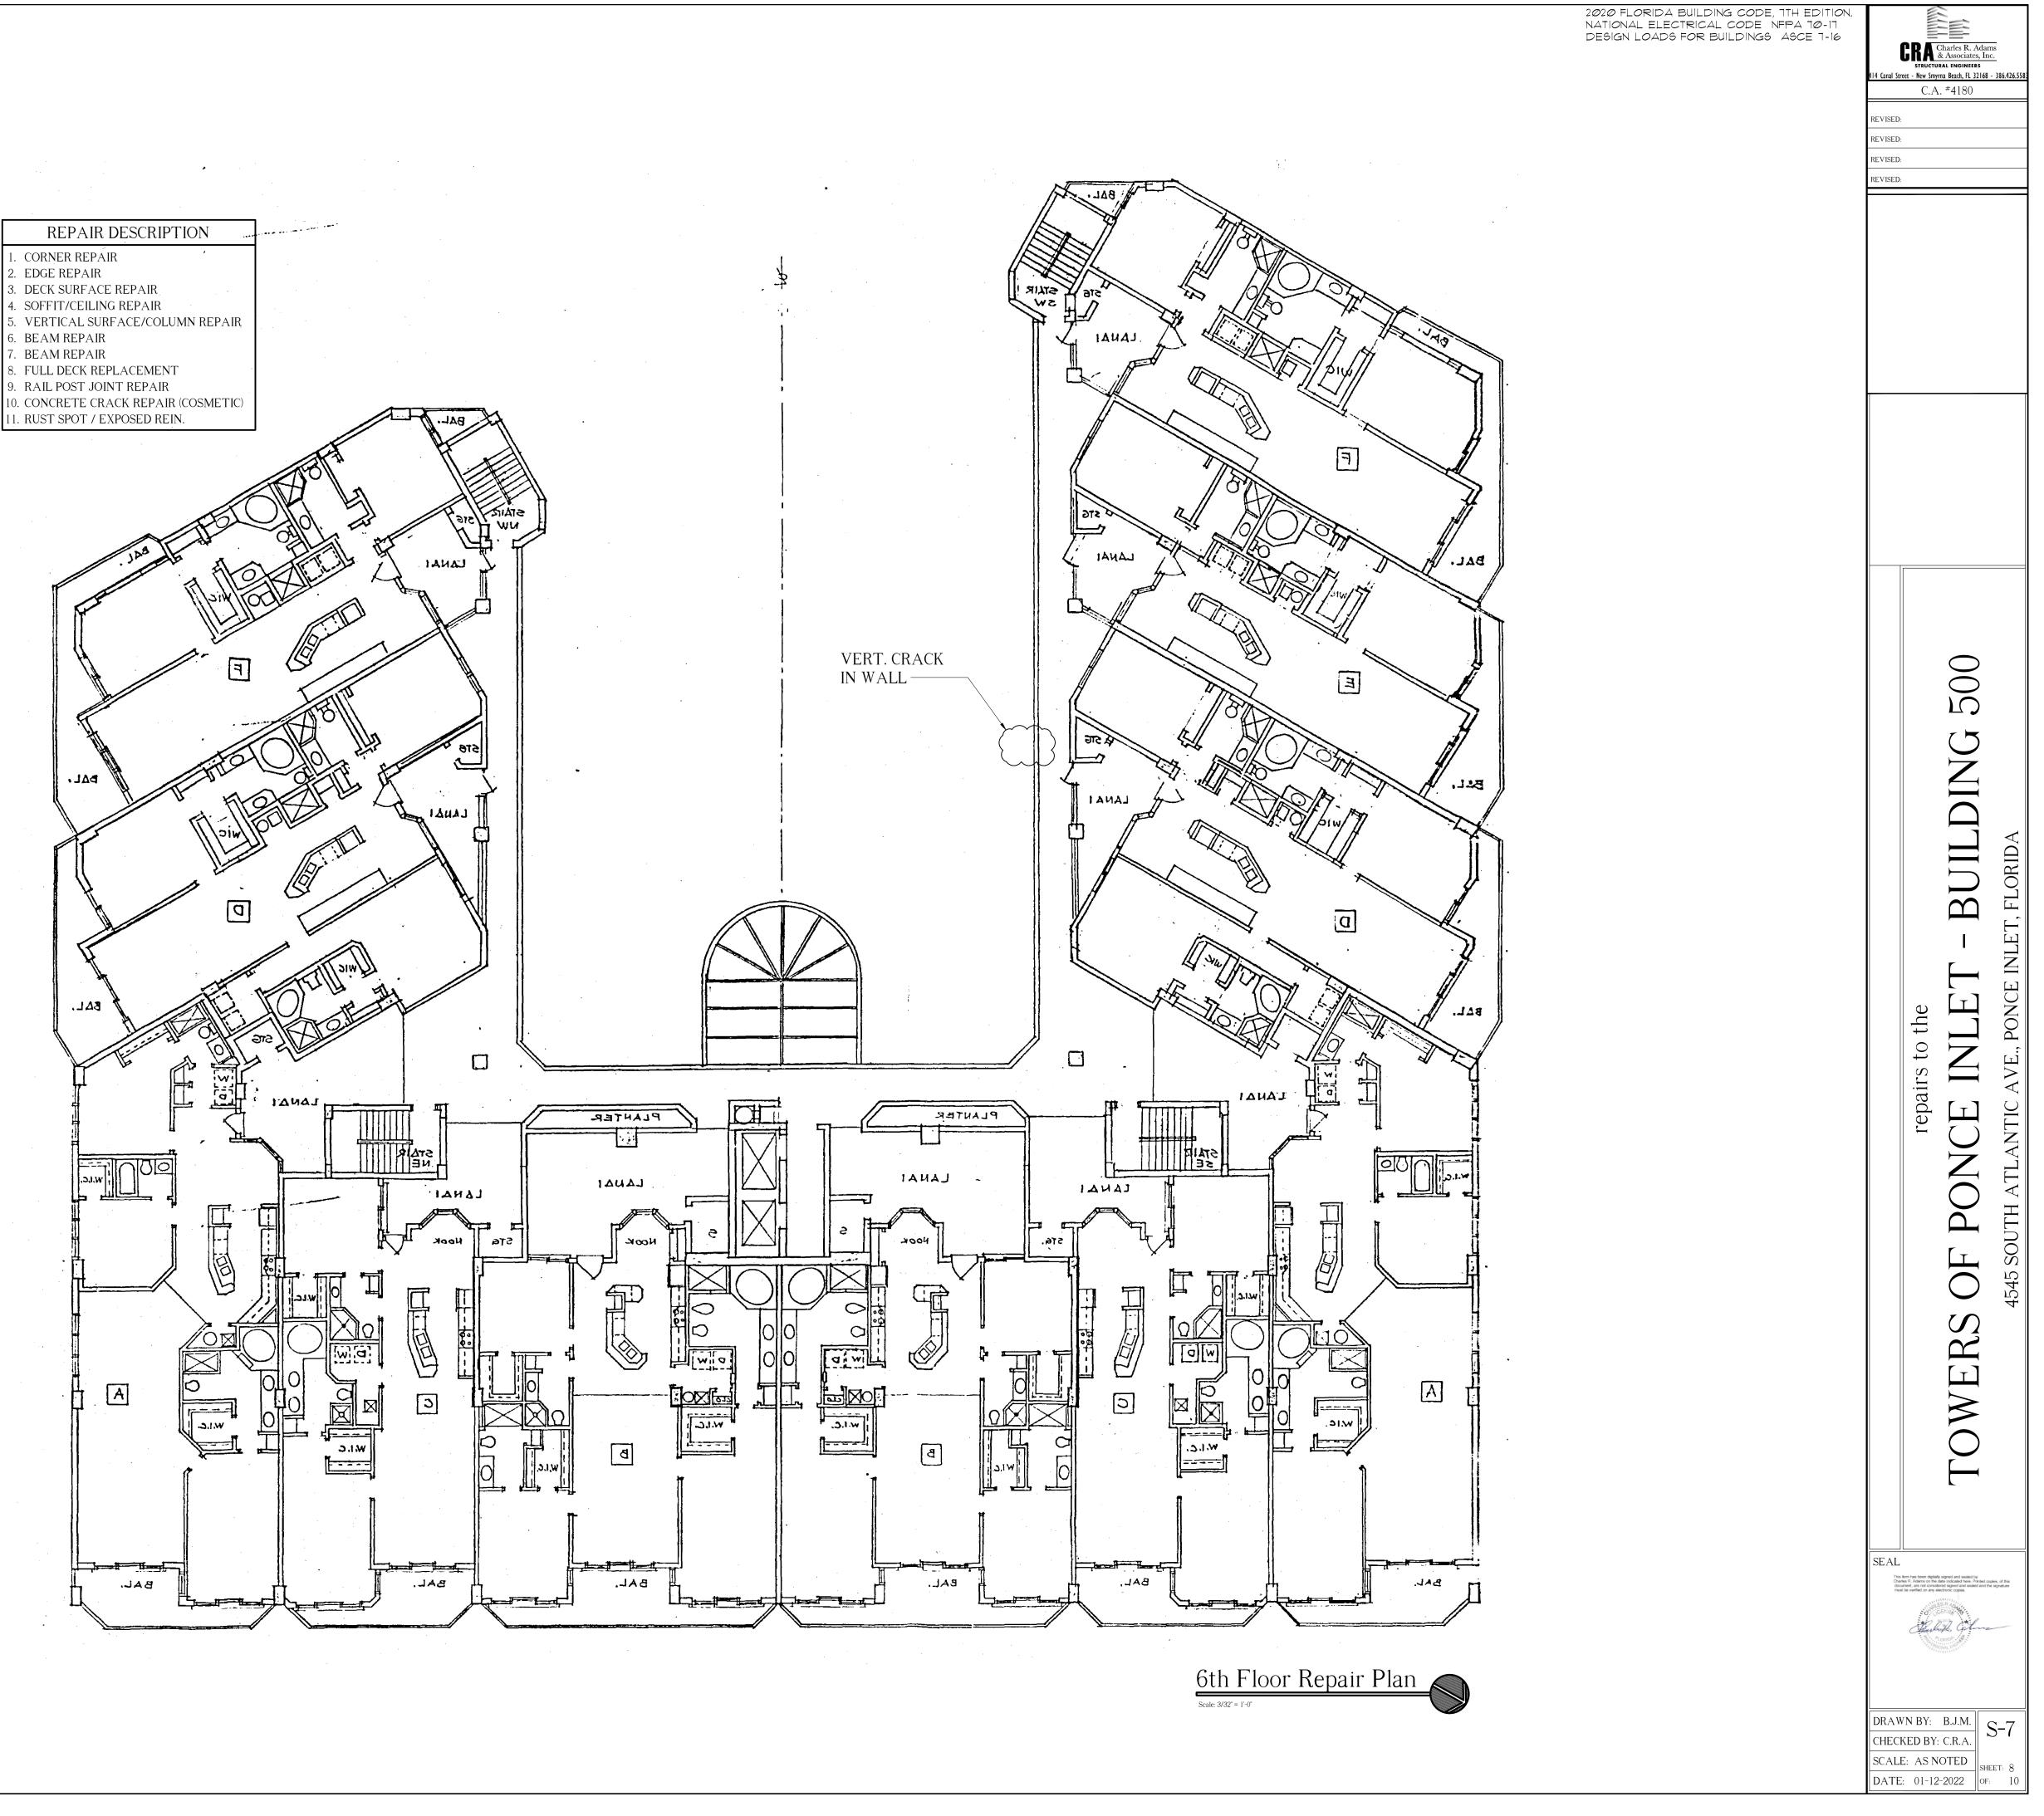
- CORNER REPAIR
- 2. EDGE REPAIR
- 4. SOFFIT/CEILING REPAIR
- 5. BEAM REPAIR

- 9. RAIL POST JOINT REPAIR

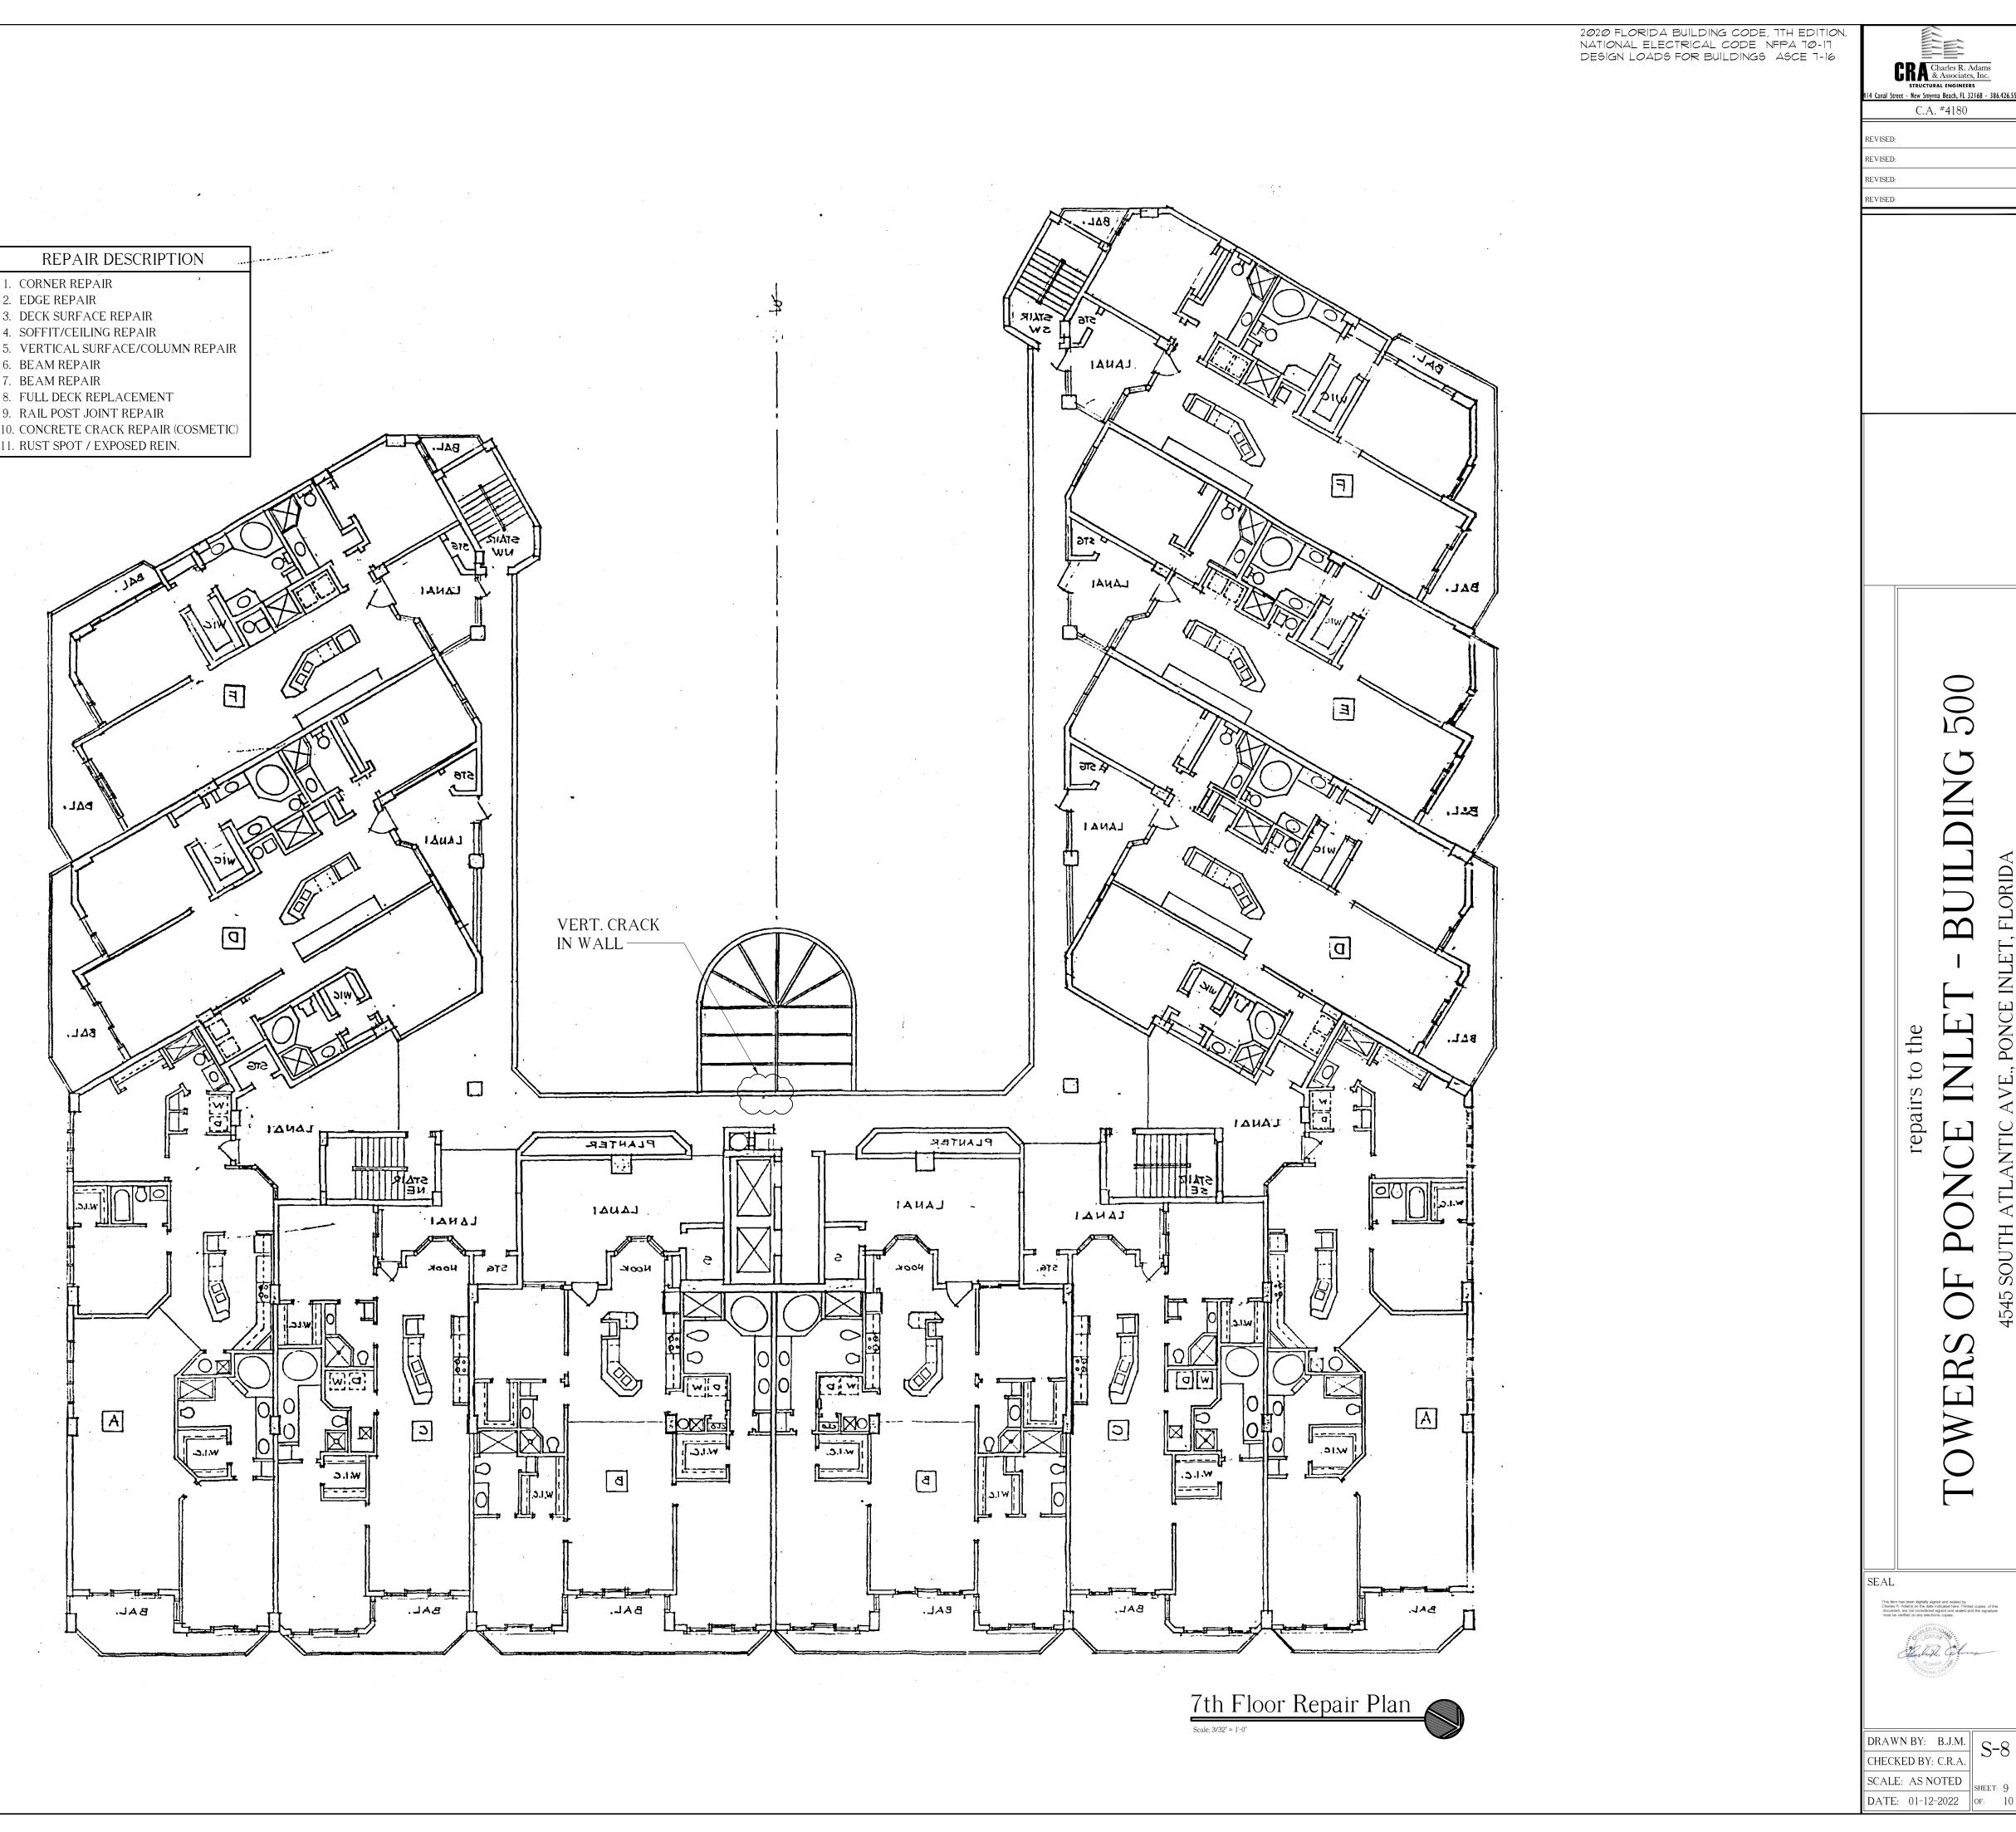
- 2. EDGE REPAIR
- 4. SOFFIT/CEILING REPAIR
- . BEAM REPAIR

- 9. RAIL POST JOINT REPAIR
